**Report No. 23-09****TESTING OF SPECTRAFORM SFUT OPEN JOINT  
UNITISED SYSTEM TO AS/NZS 4284:2008**

PROJECT: Spectraform SFUT open joint unitised system weathertightness

CLIENT: Big River Group (NZ) Ltd trading as Decortech

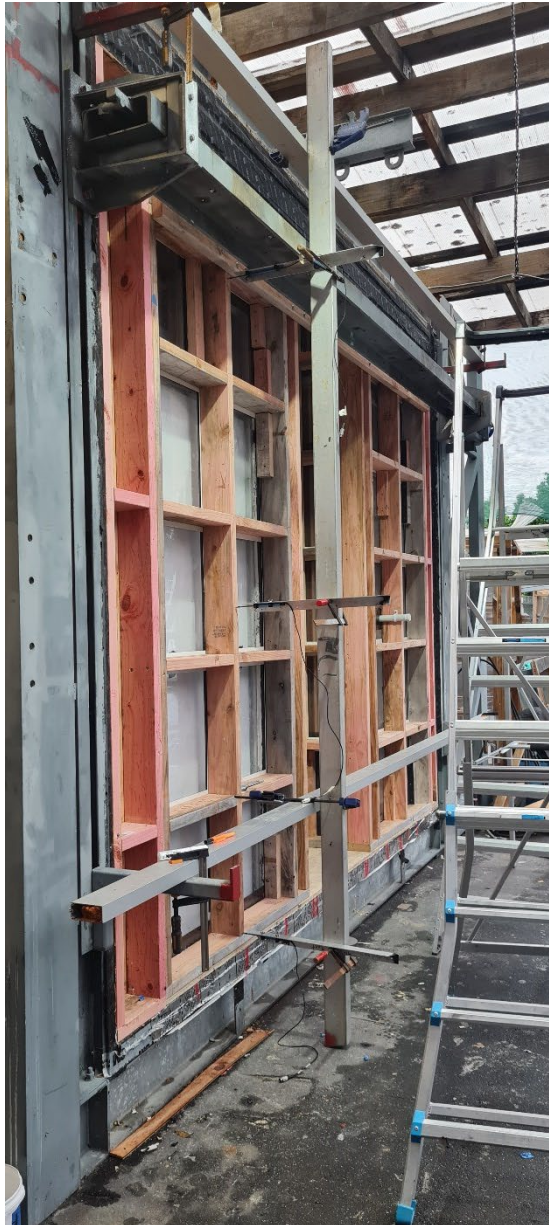
*Figure 2: SLS displacement transducers on stud*

The displacement transducers were located as close as possible to the end of the timber stud. The photo shows the actual locations as tested which was within 5 mm of the visible end of the stud.
