# Rinnai New Zealand

## Energysaver flue test report – May 2016

Test to determine the effect of connecting a Rinnai direct mushroom flue on a Vanluk MG100-18-60 penetration seal.

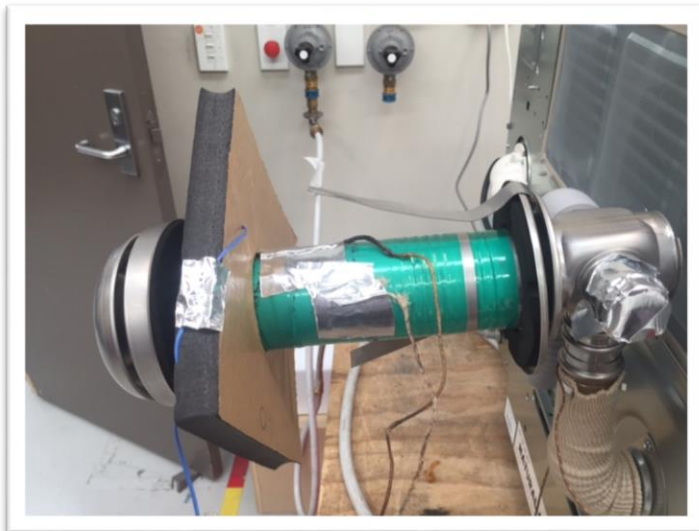
This image shows the thermocouples in position on the flue. One thermocouple is measuring the temperature of the outer flue, and one is positioned between the flue outer and the penetration seal to determine the temperature at the point of contact. An additional thermocouple is placed onto the seal material, approximately 30 mm from the flue/seal contact face to determine temperature at that point.

**Figure 1:** General arrangement of thermocouples on flue and Vanluk MG-100-18-16 penetration seal

Thermocouples were placed onto the flue and penetration seal to measure the temperatures obtained during operation. The thermocouples were retained in position with aluminium self-adhesive tape where required.

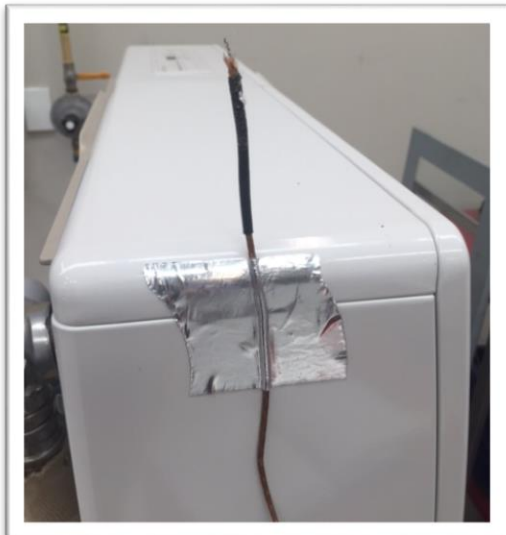
This image shows the position of an ambient air temperature thermocouple positioned out of the air flow of both the flue gas and heat output of the appliance.

**Figure 2:** Ambient air temperature thermocouple position

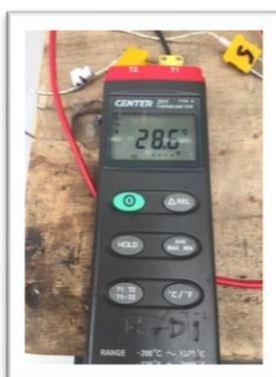
**Figure 3:** Measured air temperature 28.6 °C

| Reference | Measurement | Temperature °C |
|---|---|---|
| A | Ambient air temperature | 28.6 |

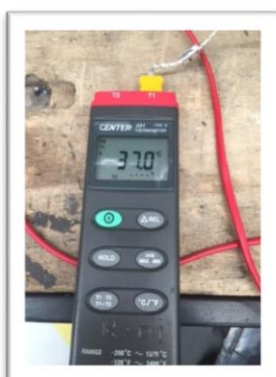
**Figure 4:** Temperature of outer flue 37.0 °C

| Reference | Measurement | Temperature °C |
|---|---|---|
| B | Outer flue temperature | 37.0 |

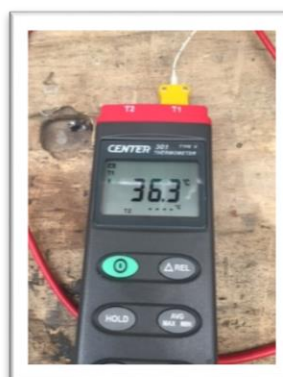
**Figure 5:** Temperature between outer flue and penetration seal 36.3 °C

| Reference | Measurement | Temperature °C |
|---|---|---|
| C | Temperature at flue/seal junction | 36.3 |

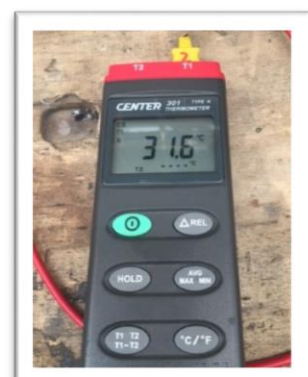
**Figure 6:** Temperature of thermocouple in seal material 31.6 °C

| Reference | Measurement | Temperature °C |
|---|---|---|
| D | Temperature of seal 30 mm from the flue | 31.6 |

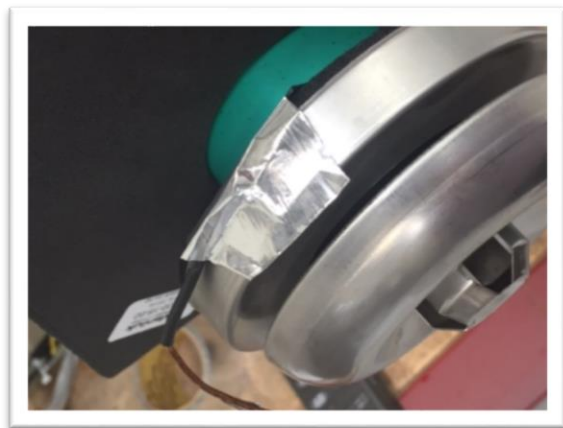
Figure 7: Location of thermocouple on the mushroom flue adjacent to likely cladding material

In addition, the temperature of the mushroom flue was determined at a point likely to be closest to or in contact with any cladding material in a given installation.

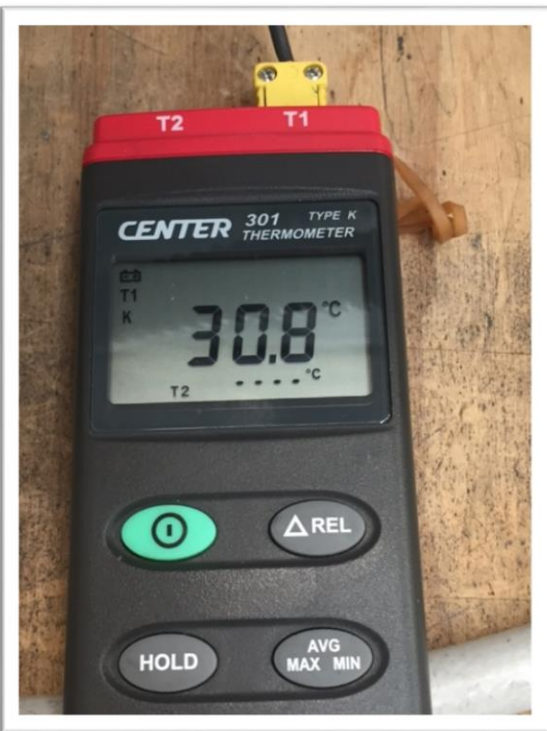
Figure 8: 30.8 °C , temperature recorded at the mushroom flue

N.B: This temperature quickly dissipated as evidenced by the mushroom temperature result recorded in figure 8.

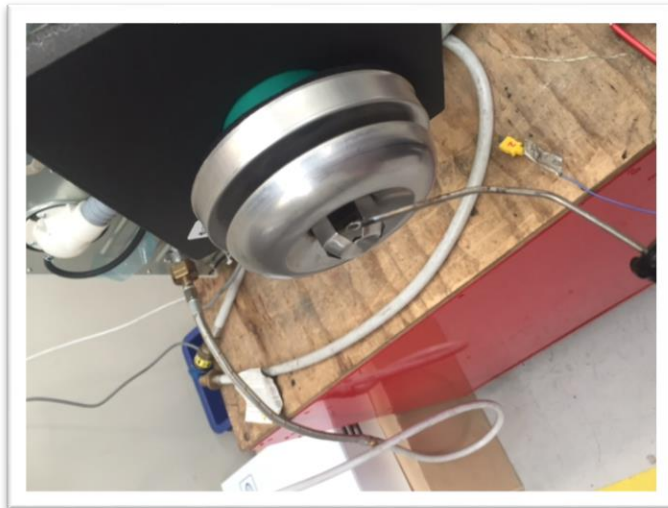
Figure 9: Temperature measurement with hand held thermocouple at flue gas exit point

A hand held thermocouple was used to determine the flue gas exit temperature from the appliance. This was measured at the point of exit from the flue. This was not in contact with any seal or cladding material.

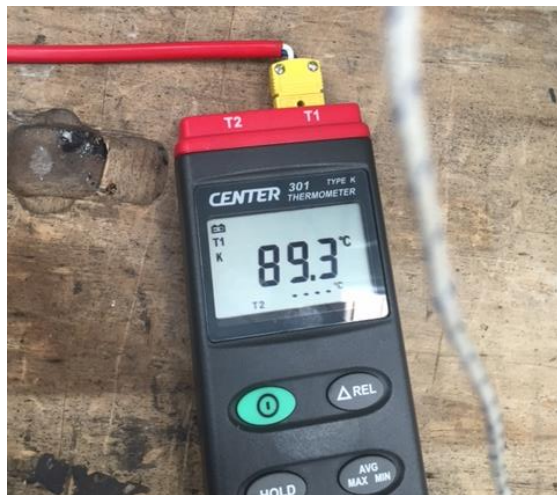
Figure 10: 89.3 °C, temperature recorded at flue gas exit point

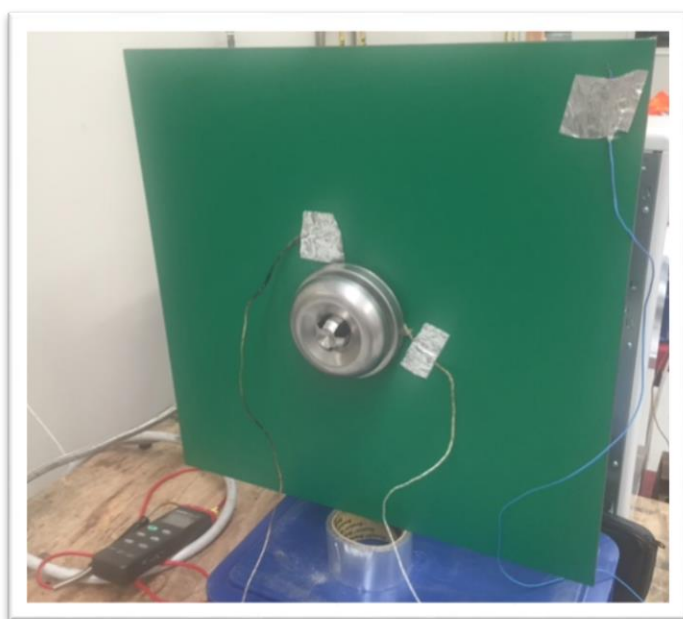
In addition to the above testing, additional testing was undertaken with a sample of 8 mm Trespa cladding material. The cladding was prepared by cutting a hole central to the sample to allow the flue to fit through with an approximate all round clearance of 5 mm. The flue component was then fitted and the Vanluk MG-100-18-60 seal was placed in its typical functional position.

Thermocouples were attached to the cladding and the heater was run on maximum for one hour. Another thermocouple was positioned to establish the ambient temperature of the test environment.

**Figure 13:** Test setup for the Trespa cladding material

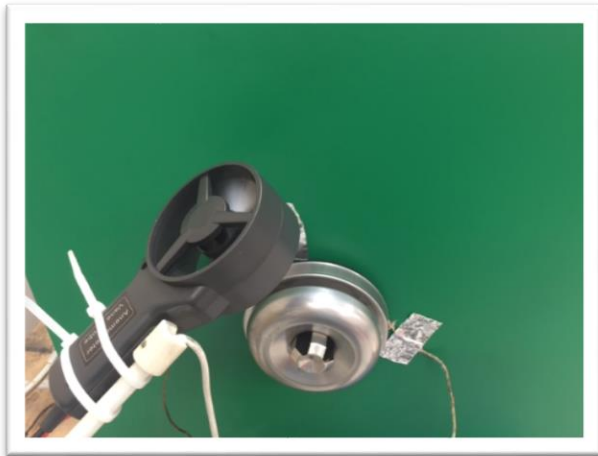
A test was carried out to establish if the flue gas plume from the appliance could directly affect the cladding material. An Anemometer was used to establish flue gas speed and the temperature when placed in the direct path of the flue gas.

**Figure 14:** Anemometer placed in the pathway of the flue gas

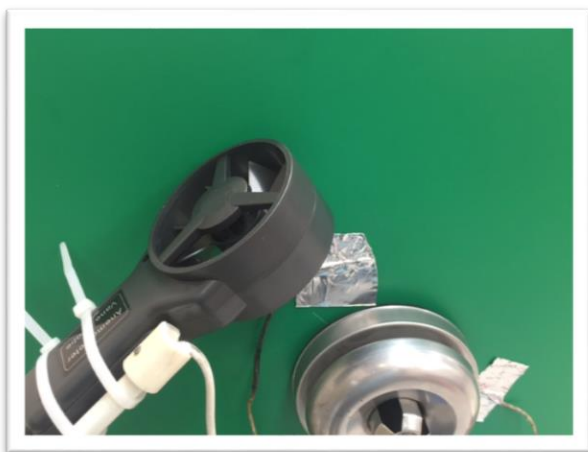
The Anemometer was then placed closer to the Trespa cladding and the flue gas speed and temperature were measured.

**Figure 16:** Position of Anemometer close to the Trespa cladding

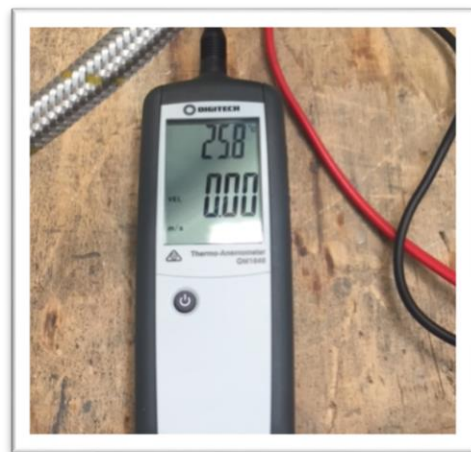
**Figure 17:** Results from Anemometer 2 and no air speed

The results indicate that there is no direct impingement of the flue gas onto the Trespa cladding material. Further validated by a series of FLIR images, which were taken of the test setup to determine if the flue was heating any part of the cladding material, refer images on next page.

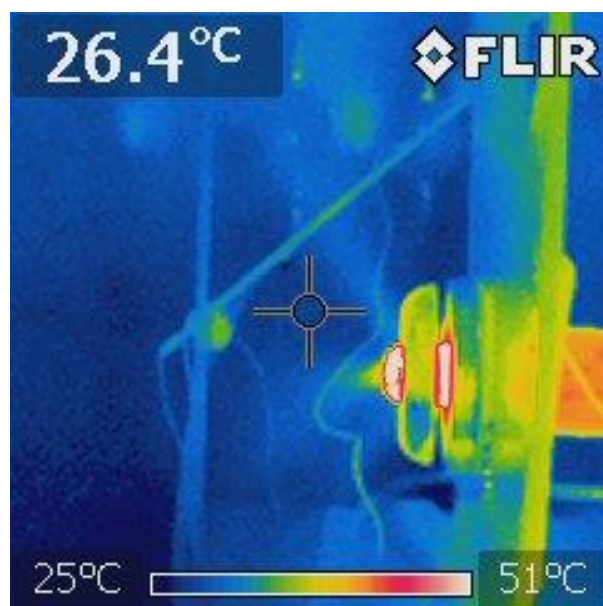
**Figure 20:** Showing the flue gas plume exiting the flue termination
