**TEST REPORT No. T394**

Performance tests on Trespa TS35 cladding system in accordance with  
New Zealand Building Code E2/VM1

## TEST REPORT No. T393

Performance tests on Trespa TS35 cladding system either directly fixed to the rigid air barrier or fixed to battens in accordance with AS/NZS 4284: 2008 Testing of Building Facades.

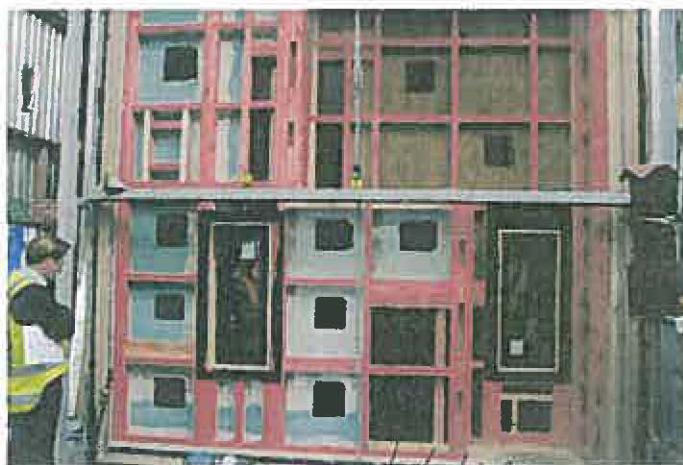
Following removal of all internal linings and removal of the building wrap or air barrier panels, the test specimen is subjected to the Wet wall test, being the application of a static pressure of 50 Pa across the cladding face with the external water spray continuing. With the test sample being built with rigid air barrier panelling it was necessary to cut a series of large holes in the panel to achieve the equivalent pressure equalisation to the internal space. The holes were made at locations to allow inspection of areas adjacent to the location of the 6 mm Water Management test holes as well as around other penetration zones. (see photo)

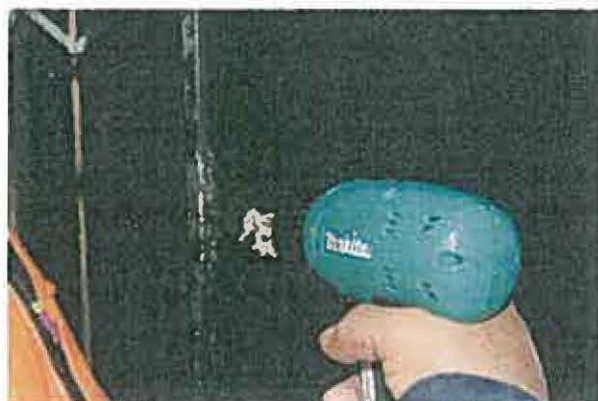
Water management test - 6 mm hole locations

Through external corner joint seal

1. Through external corner joint seal
2. Through internal corner joint seal
3. Through panel below rail
4. Through panel vertical lap joint
5. Through panel diagonal lap joint

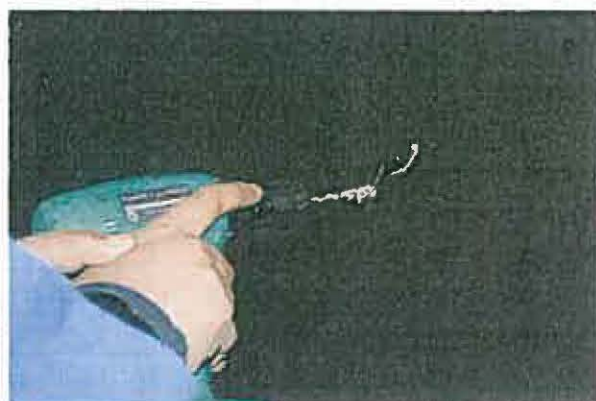
Through internal corner joint seal

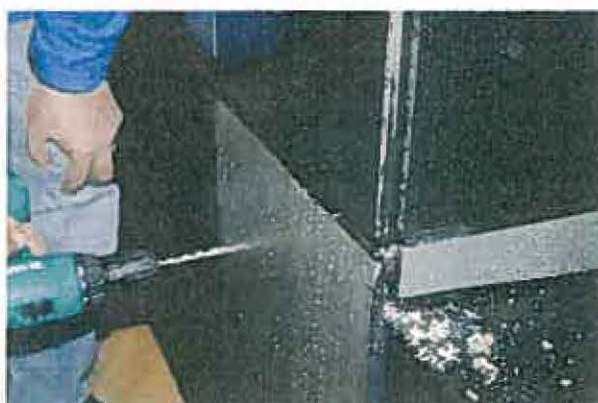
Through panel below rail

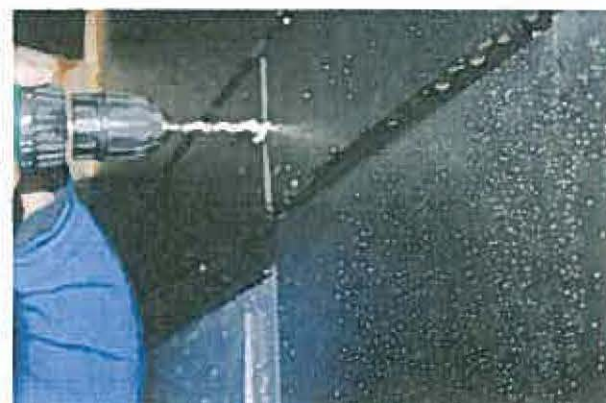
Through panel vertical lap joint

- 3) The vertical panel to panel shiplap joints were not tight across the full height of the panel; the following corrective action has been initiated
  - vi) The introduction of a backing rail TS35-21 with santoprene gaskets fitted between the TS35-11 and TS35-3 will ensure compression between the 2 Trespa Meteon sheets as per detail TP-RB 11 and allow relative trans directional movement to be maintained, and also enhances the weather tight performance of a joint should it contain a defect. In the test this defect was simulated by drilling a 6mm diameter hole through the joint.

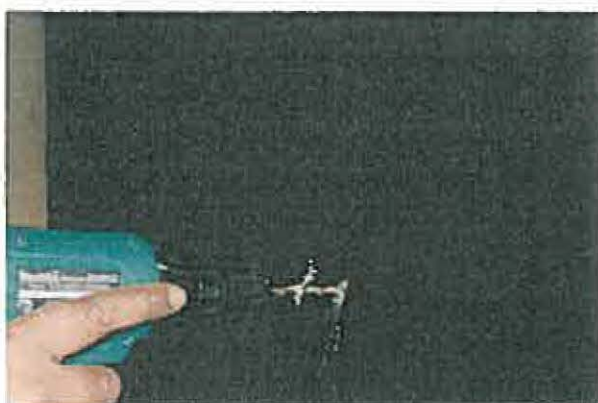
Through panel diagonal lap joint

However a flashing detail at the aluminium rail at the top of the diagonal Trespa panel lap joint allowed water penetration into the internal diagonal rebate that was subsequently able to drip off succeeding rails into the cavity space.

The clients have reviewed this detail and found a lack of sealant application at the rear upstand edge of the aluminium soaker (original detail illustrated on TP-RB-05) The clients have produced a summary of the cause of the water penetration and a detailed procedure to eliminate this (attached as Appendix 1)

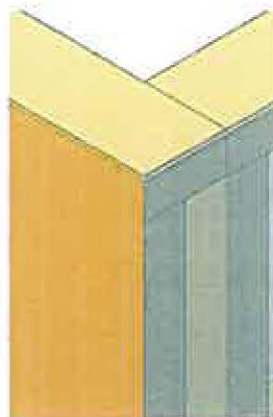
1 RIGID BARRIER - EXTERNAL CORNER

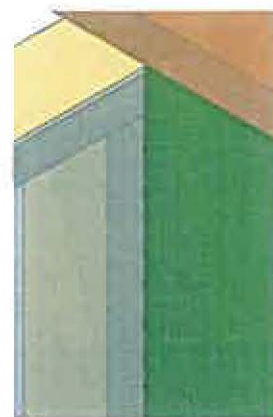
2 RIGID BARRIER - INTERNAL CORNER
