**Report No. 23-09****TESTING OF SPECTRAFORM SFUT OPEN JOINT  
UNITISED SYSTEM TO AS/NZS 4284:2008**

PROJECT: Spectraform SFUT open joint unitised system weathertightness

CLIENT: Big River Group (NZ) Ltd trading as Decortech

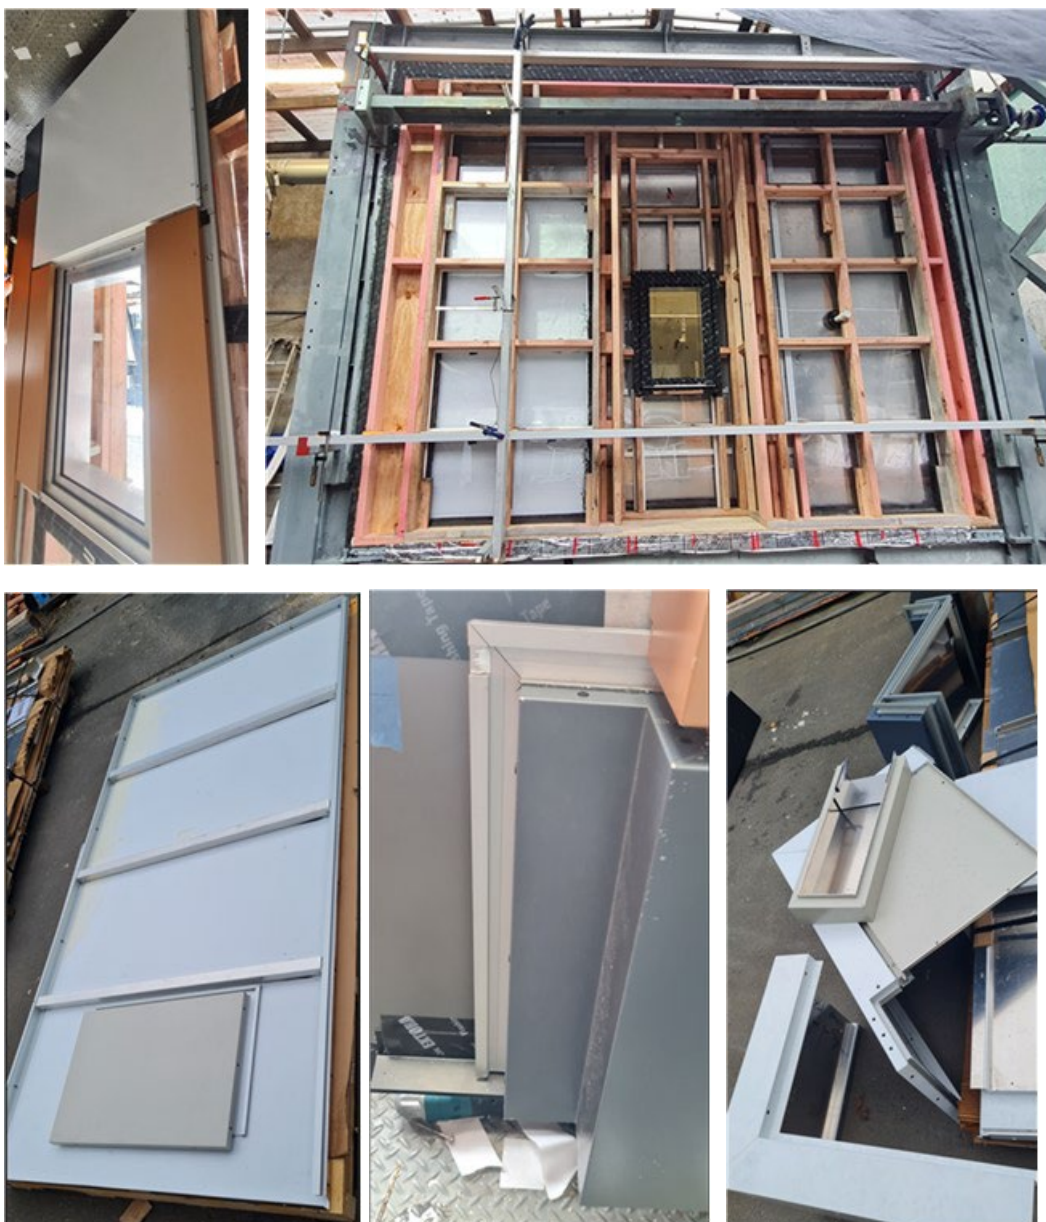
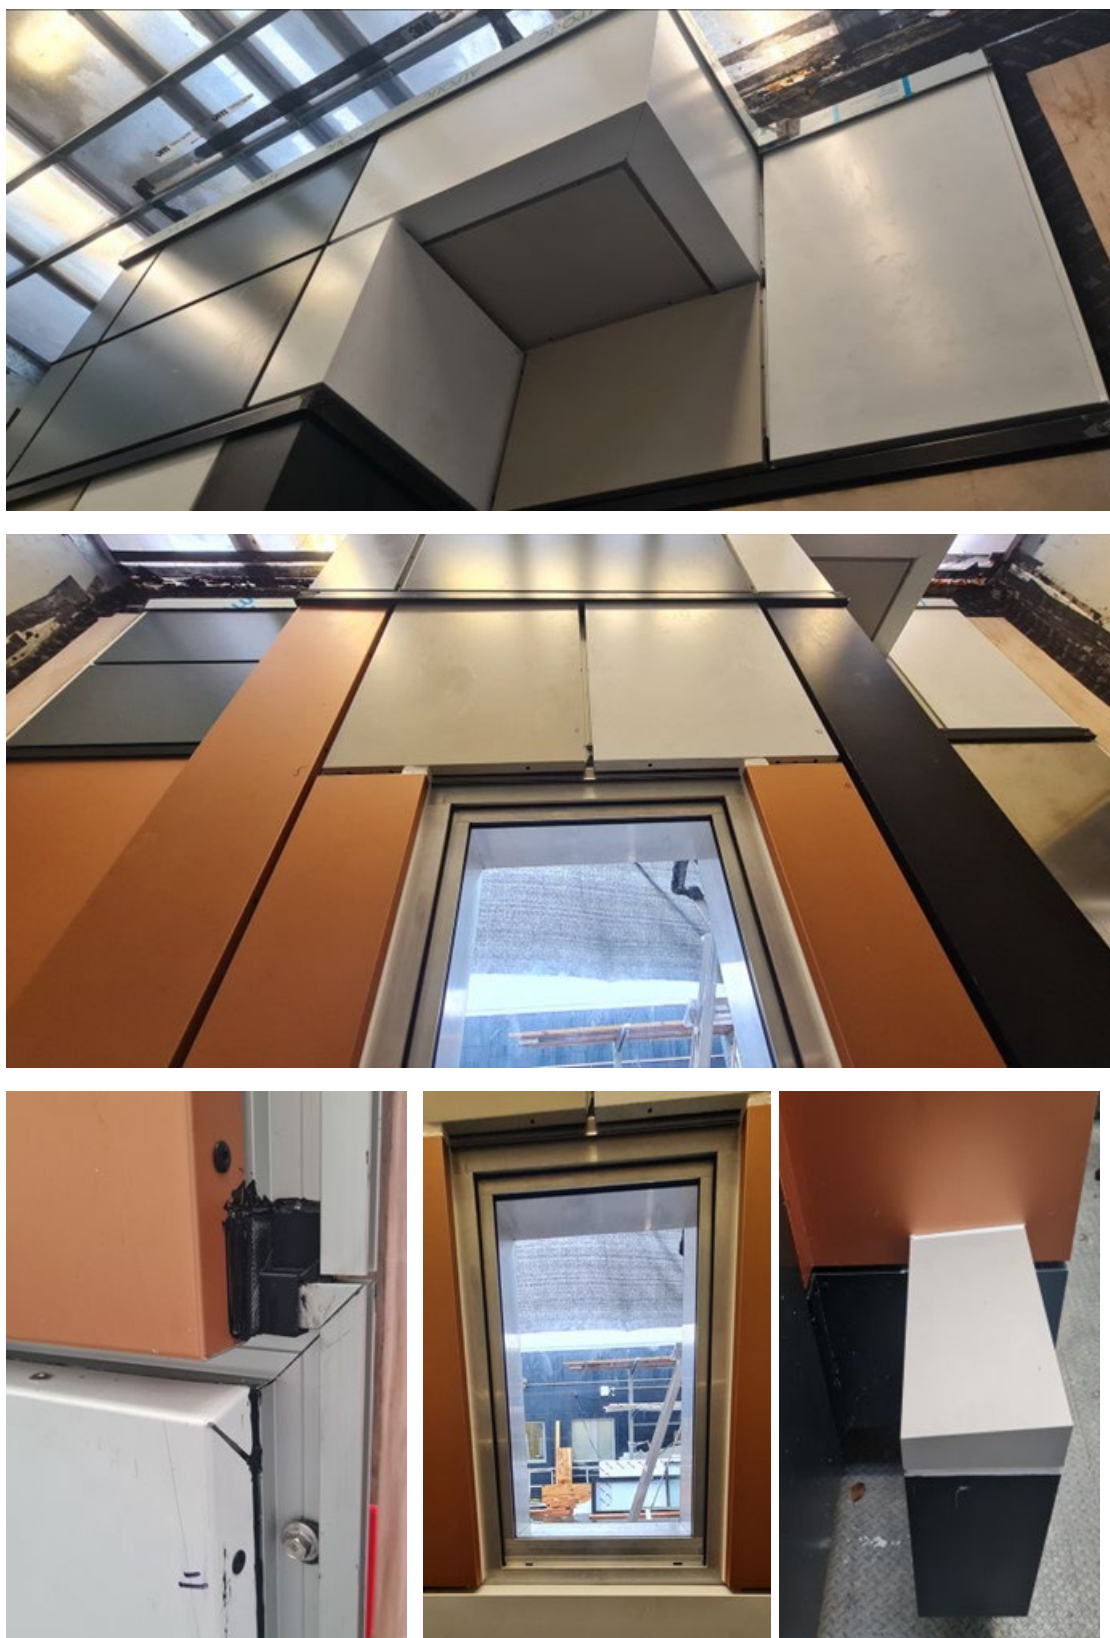
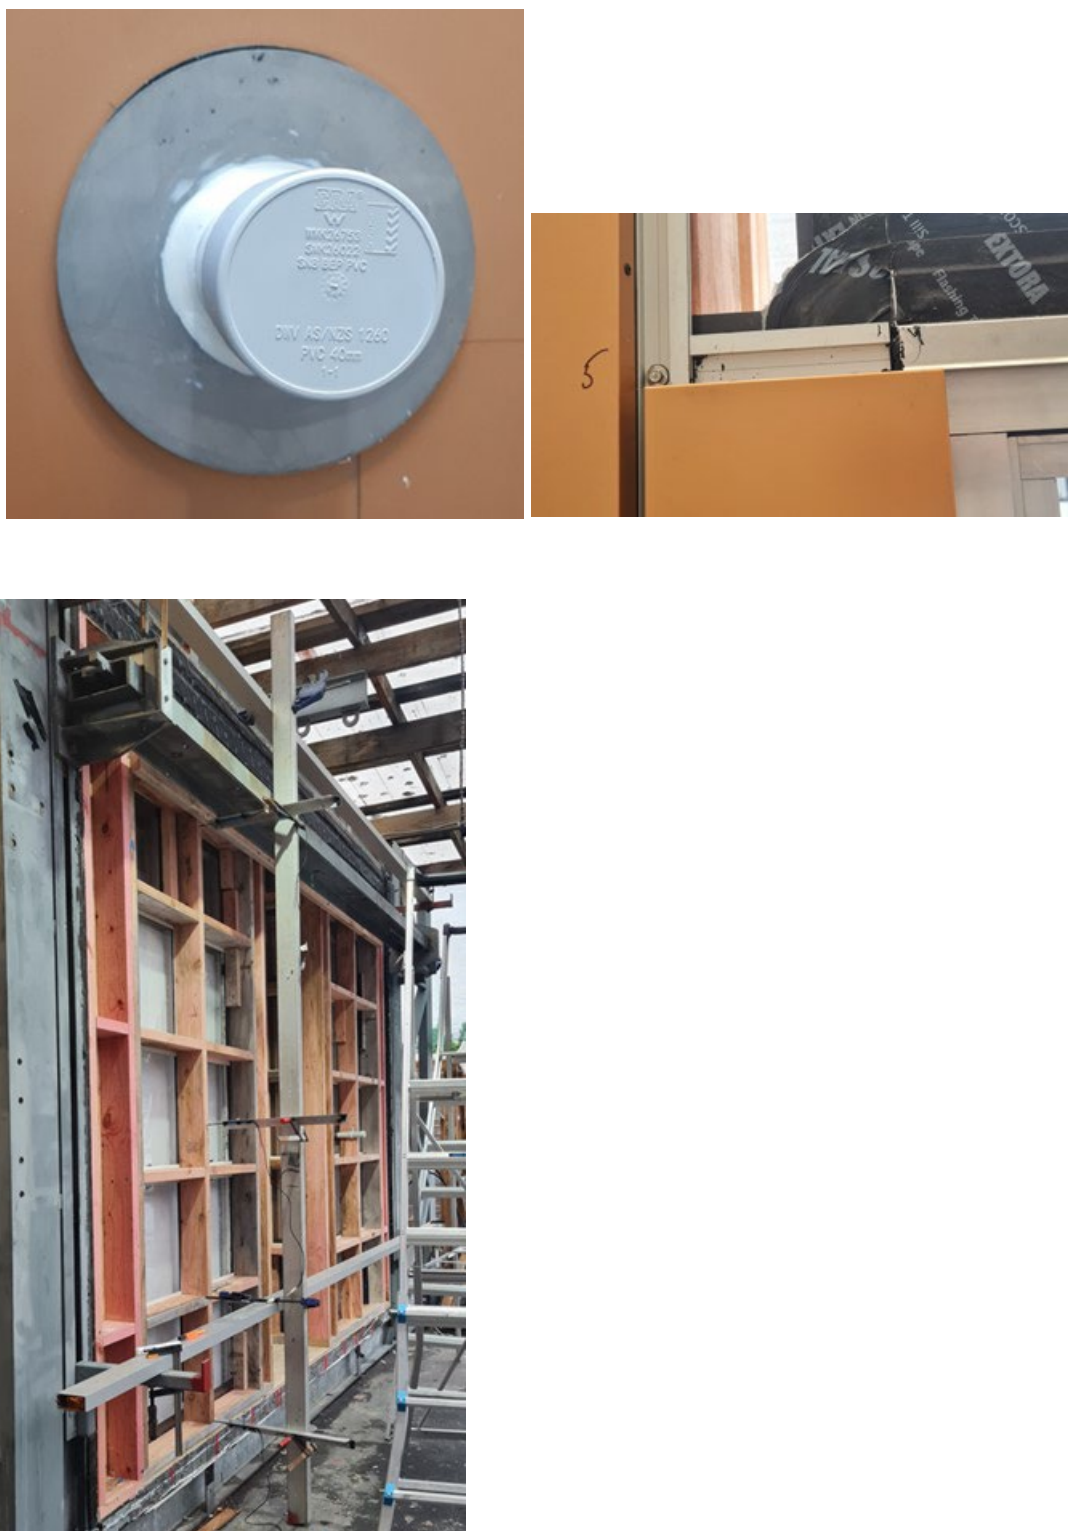
*Figure 3: Selected Photos from Testing*

As the testing progressed, several elements had leakage that could not be addressed, so these elements were removed from the test. These included:

- covering the fixing rivets (at the head of the cassette only) since they were open and allowed water and air to pass through some of the connections.
- the sill/jamb junction was over-sealed at RHS (from inside)
- the window glazing joints were taped up since they were leaking water

There were occasional water leaks through the cladding system, which remained on the back of the cladding, although some water was able to contact the inside of the polycarbonate which was taking the place of a rigid air barrier. This does not demonstrate non-compliance with the requirements of the test; however, the client was interested to reduce or eliminate this water.
